NASA Work on Fatigue-Induced Cracking of H₂ Flow Control Valve Poppet

Miguel J. Maes

NASA WSTF

June 24, 2009

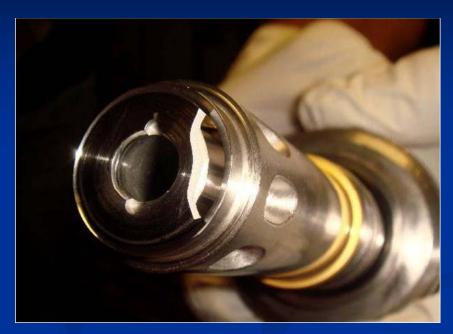
- A piece of the flow control valve poppet was missing
- The HFCV works like a pop-up sprinkler to allow more GH₂ to flow

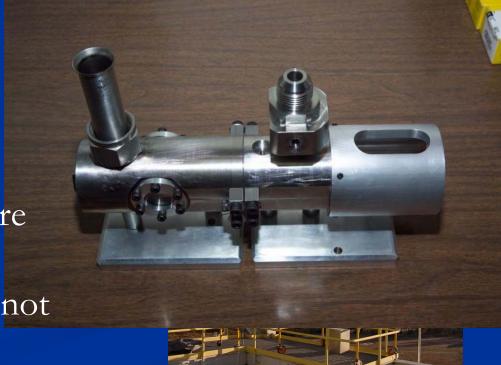
- Testing:
 - o Particle Release Testing

After all preparations were made, testing at SSC was cancelled, this apparatus no

used
